Sentinel

surround sound audio monitor

Release Notes

Version 1.34a
July, 2013

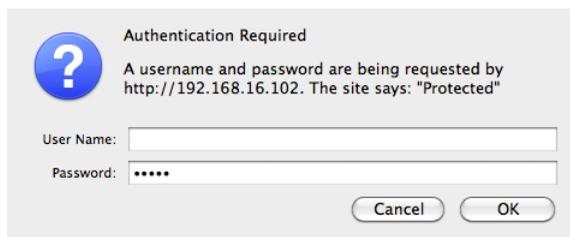
The Sentinel will display a pop-up menu that prompts you for a User Name and Password:

Leave the User Name blank; the default password is *audio*.
